M939-Series Trucks...

ONE THING LEADS TO ANOTHER

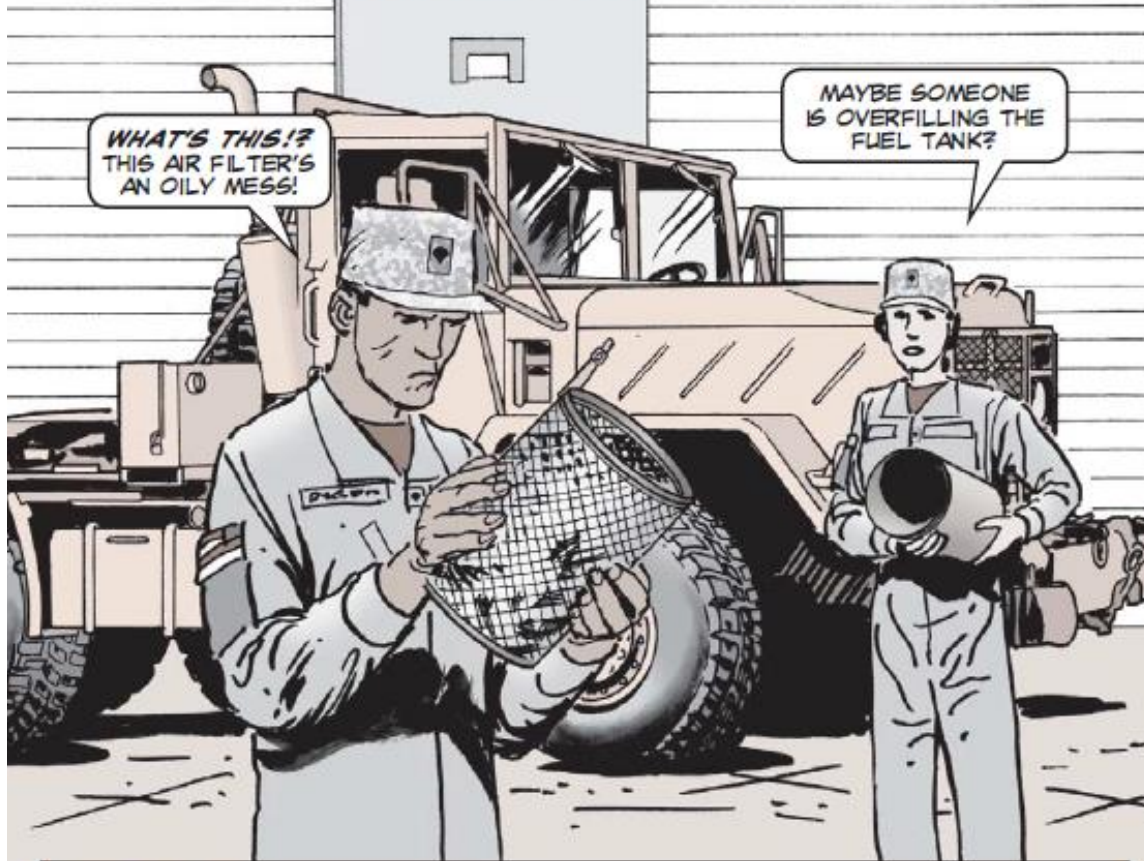
No way is oil supposed to be in the 5-tonner's air filter, but there it is—something that looks like oil. So where did it come from?

Fouled air filters often start with an overfilled fuel tank.

How does that happen? Well, one thing leads to another.

The fuel tank, transmission gear case and transfer gear case all vent into the air cleaner duct. Fuel from an overfilled tank can run through the vents and end up in the gear cases. Then, the fuel-oil mess from the overfilled gear cases is forced out through the vent lines... and ends up in the air filter.

It's also possible that a leaking interlock air cylinder can pressurize the transfer and push oil into the air filter.

Regardless, if the air restriction indicator in the cab shows red, check the air cleaner. If it's oil-clogged, check the levels in the transmission and transfer gear cases. If they're overfilled, have your mechanic drain the excess. Oil in these components may contain fuel. Sniff the oil, and if you smell fuel, change the oil.

If either gear case is low, support can check the transfer interlock air cylinder for leaks.

A good reminder not to overfill the fuel tank is to paint a line two inches from the top of the tank. Then, stencil "**CAUTION: Do not fill above this line to allow for expansion**" in 1-in black letters as shown in Fig 20 of TB 43-0209, Color, Marking and Camouflage Painting of Military Vehicles, Construction Equipment and Materials Handling Equipment (Oct 90 with Change 1, May 91).

Also, an expired MWO 9-2320-272-20-6 installed a fuel tank ventilation kit that prevents oil from getting forced into the air cleaner element and housing.
